CEME Emergency call

Project news

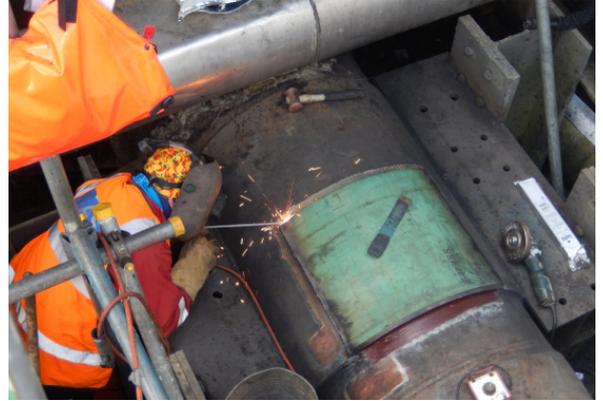
coupon to the tolerance detailed in the weld procedure and complete the weld. Inspection of the coupon was restricted so a special variation of Phased Array had been agreed. This is a very rare inspection technique and was in addition to standard NDT.

After acceptance of the weld, the reinforcement sleeve was replaced with a new section of the same material and welded in situ.

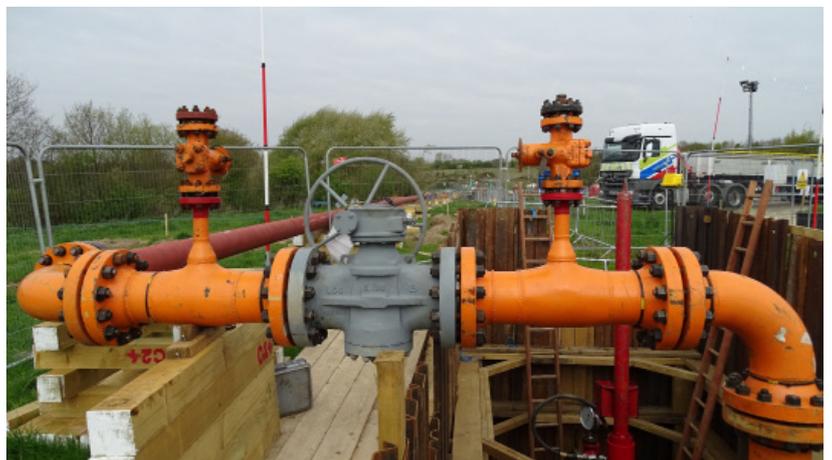
We welded 10 connections and fitted an epoxy sleeve after a girth weld failed a Phased Array (see picture right).
