Project news

PMC works with GTD and others to create a bespoke engineering solution at Peterborough Compressor Station and repairs an emergency whilst on-site!

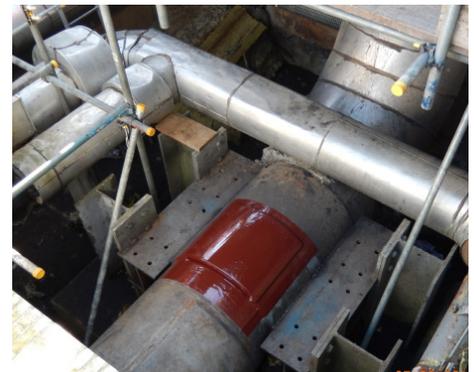
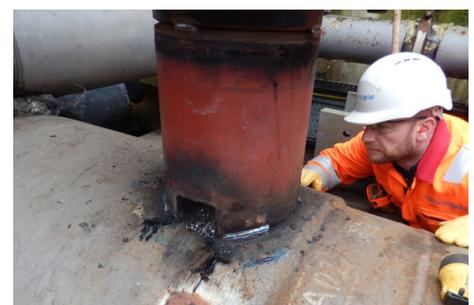
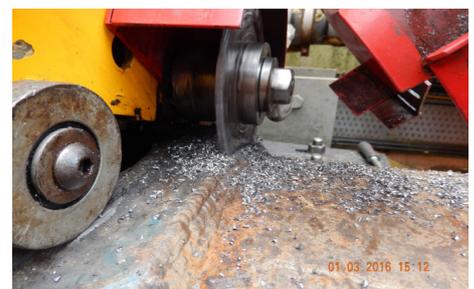
A 2” diameter class 600 flange connection had a cracked weld at its base. Removing this section of pipe would involve a re-design of the compressor pipework. This was not possible in the timescales, if at all.

PMC developed a solution to insert a solid coupon into the pipe and then weld it in (see picture left).

Then, we prepared the hole in the pipe to receive the pipe coupon and position the

coupon to the tolerance detailed in the weld procedure and complete the weld. Inspection of the coupon was restricted so a special variation of Phased Array had been agreed. This is a very rare inspection technique and was in addition to standard NDT.

First, PMC had to develop a stand to connect the drilling machine. The driller had to have extra swarf holes added as the amount of swarf was so large it would have jammed the cutter.

We had to remove the fitting and surrounding pipe sample in one piece. This meant manufacturing a bespoke cutter with three teeth and also developing a special pilot drill to match the centre of the cracked fitting to ensure the fitting was removed when the drill retracted instead of falling into the pipe.

Next we had to remove a section of the wrap around pipe support. This was done by using two different metal cutters. These cutters are used in Gas Distribution (now Cadent) and had to be adapted. We also had to ensure we did not go through the sleeve material and into the pipe material.

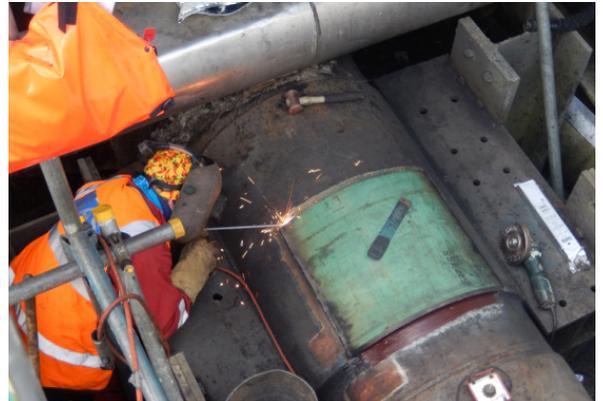
After acceptance of the weld, the reinforcement sleeve was replaced with a new section of the same material and welded in situ.
