CEME Emergency call

Project news

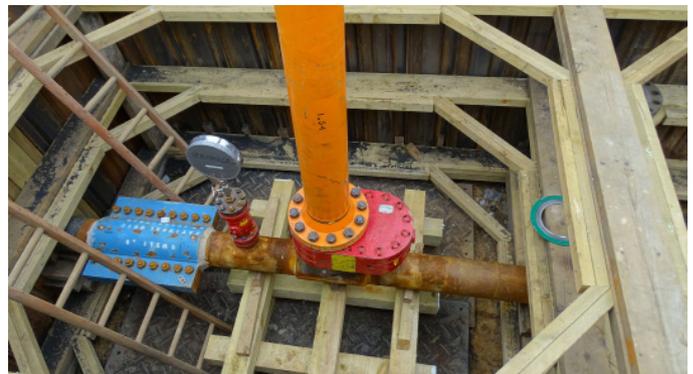
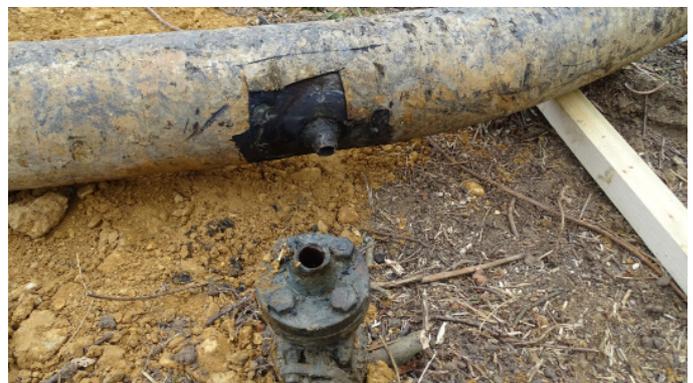
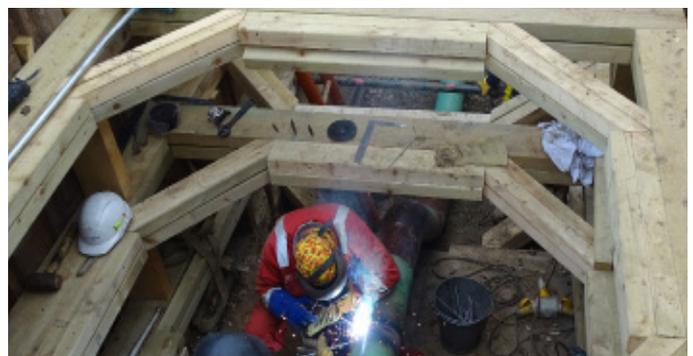
The customer scanned the defective pipework and sent the drawings over to PMC. We manufactured the replacement pipe in Ambergate, followed by a 24 hour pressure test.

PMC and the customer laid the new pipe next to the old pipe so that it is in position and can be fitted immediately after the cut out. After the pipe had been laid in place, PMC use the cold cut machine to start the cut out of the pipe. The old pipe was cut in three places to remove it. The defect is then discovered on a valve fitting.

PMC welders Louis and Luke Watson weld the pipe in place and it is x'ray'd and tested.
